AVIATION INVESTIGATION REPORT

A01Q0122

RISK OF COLLISION

DORVAL / MONTRÉAL INTERNATIONAL AIRPORT, QUEBEC

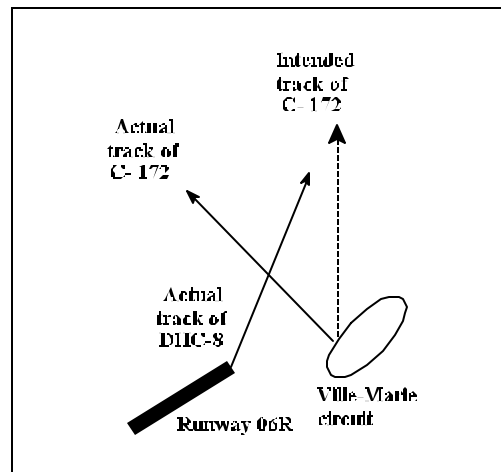
Intending to watch the fireworks at the La Ronde amusement park on Sainte-Hélène Island, Quebec, a pilot rented a Cessna 172N, owned by Cargair Ltd. Around 2150 eastern daylight time,¹ the Cessna, with the pilot and three passengers on board, took off from Mascouche Airport on a sightseeing flight over Montréal under visual flight rules (VFR). Before entering the Dorval control zone, the pilot established communications on the Dorval tower frequency and was identified by radar. He received clearance to fly over Montréal and follow the Ville-Marie sightseeing circuit, maintaining an altitude of 1700 feet above sea level (asl). The Ville-Marie circuit is oval-shaped and allows aircraft to fly over the city while remaining south of the departure paths of Dorval / Montréal International Airport runways 06R and 06L. The circuit extends about 8 nautical miles (nm) from northeast to southwest. The southwest end is closest to the airport, 4 nm east of the Runway 24L threshold (the end of Runway 06R). (See Figure 1).

Besides showing that the Cessna's Mode C was transmitting altitudes that varied from its actual altitude by more than 300 feet, radar data also revealed that the Cessna, from the time it left the circuit, maintained a heading of about 300° instead of the northerly heading assigned to it by the tower. Figure 1 indicates that the Cessna crossed the flight path of the DHC-8 sooner than expected, allowing less time for the DHC-8 to reach a higher altitude than the

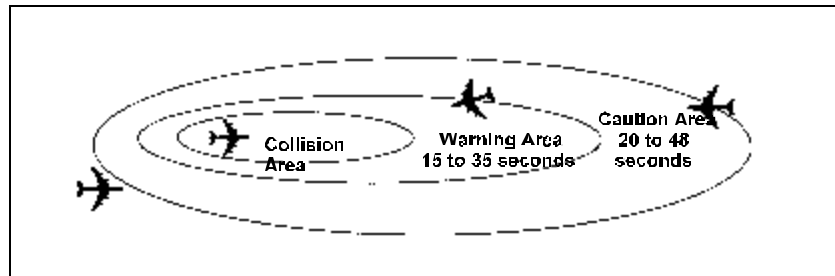
Figure 2

The return signal is tracked by the TCAS, allowing it to predict the track of an aircraft. The TCAS is designed to prevent other aircraft from entering a collision area. (See Figure 2.) The TCAS defines a collision area as a three-dimensional airspace whose dimensions vary according to the closure rate. If an aircraft is on a track that will lead it inside the collision area around an aircraft equipped with a TCAS, the system will issue an advisory to the pilot. The
